AISI – 4 point bend fracture samples 16MnCr5
Iteration 190 (Shallow CD)
Iteration 194 (Deep CD)
J. Brown 5/23/2017

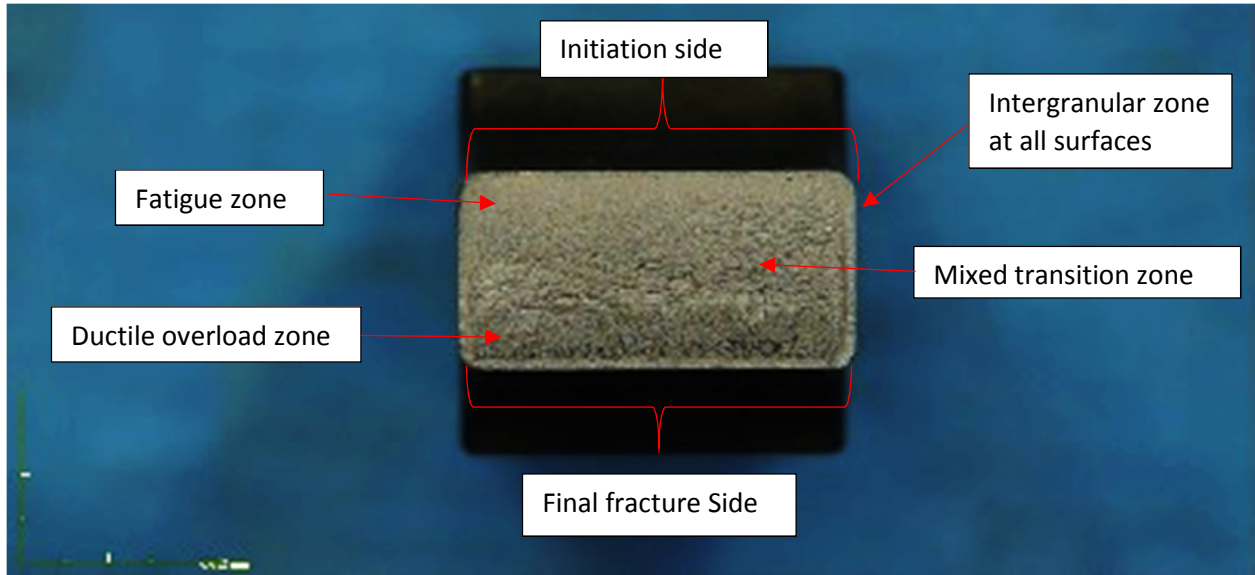
Figure 1 – Representative fracture photograph (iteration 190 – SN 3, 11, 15, 19, 20 and iteration 194 – SN 3, 34).

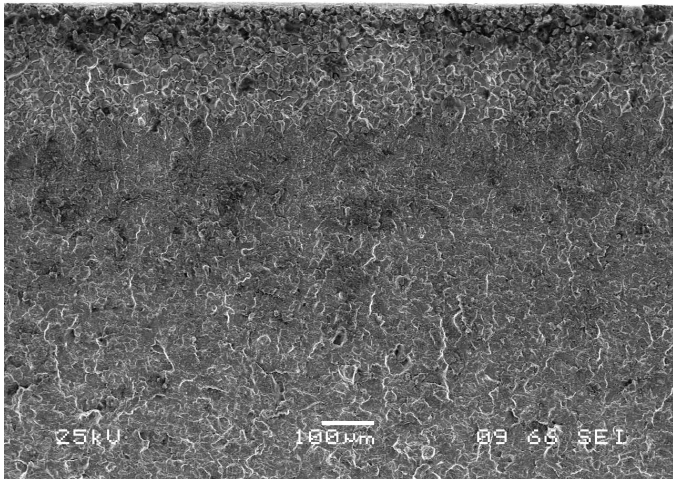
Figure 2 – Fracture surface at the initiation side.

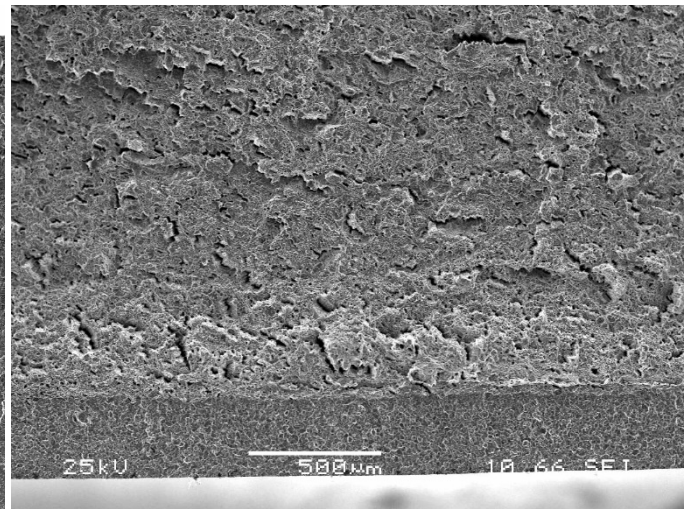
Figure 3 – Fracture surface at the final fracture side.

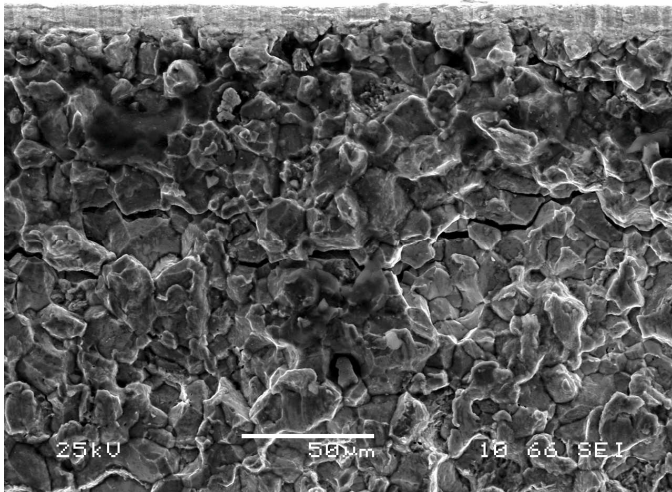
Figure 4 – Representative photograph at the surface showing intergranular fracture.

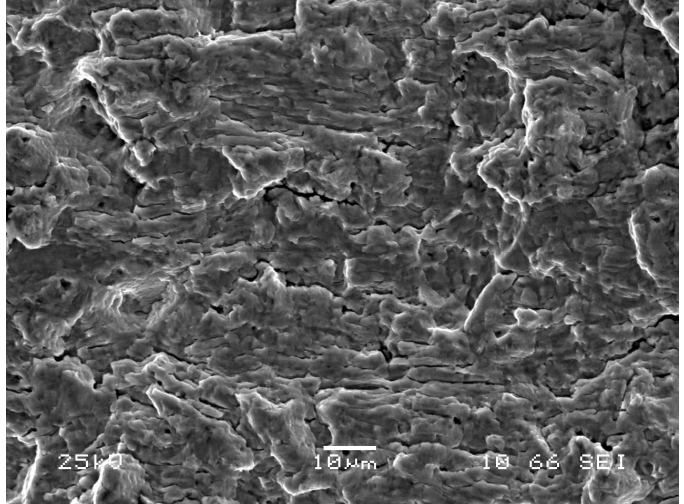
Figure 5 – Representative photograph of the fatigue zone. Showing micro-tearing and some striations.

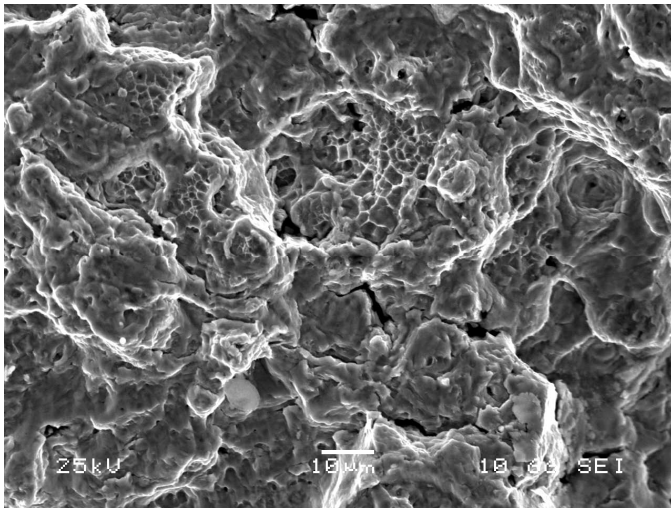
Figure 6 – Representative photograph of the transition zone (changing from fatigue to ductile overload).

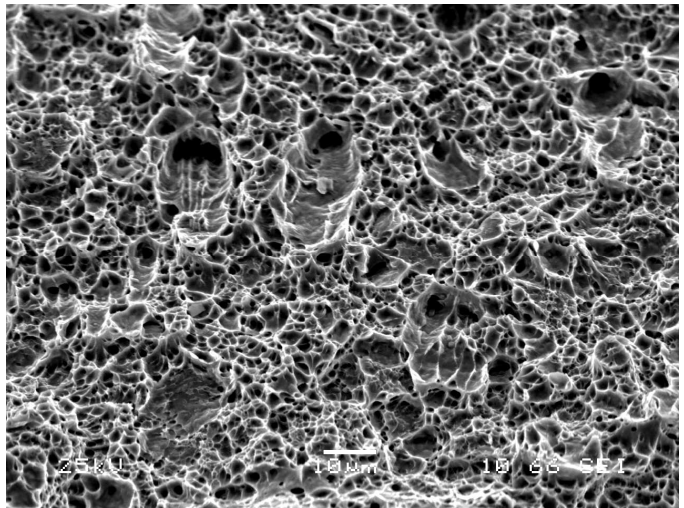
Figure 7 – Representative photograph of the ductile overload zone showing ductile dimple morphology.

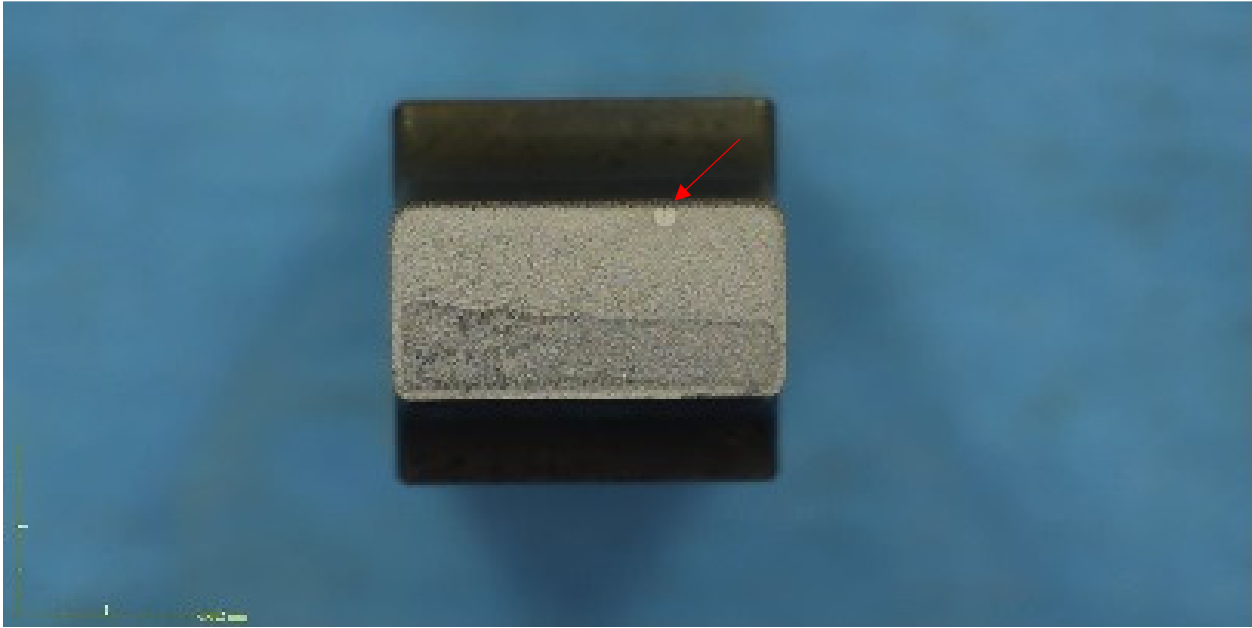
Figure 8 – Showing the fracture surface of iteration 190 SN 16.
Arrow shows location of subsurface burst as the initiation.

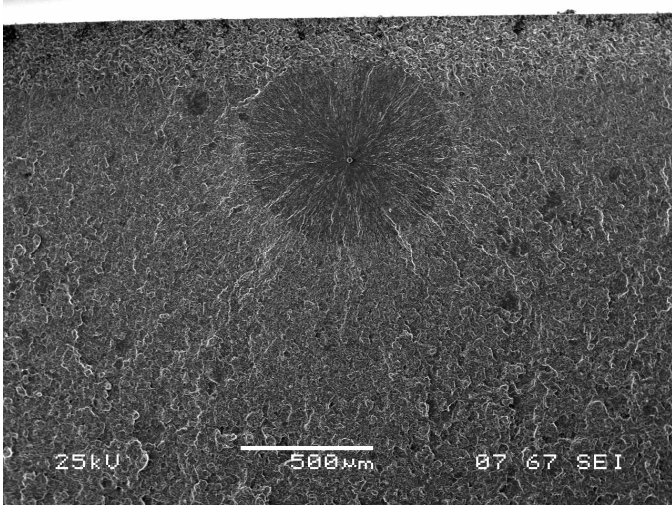
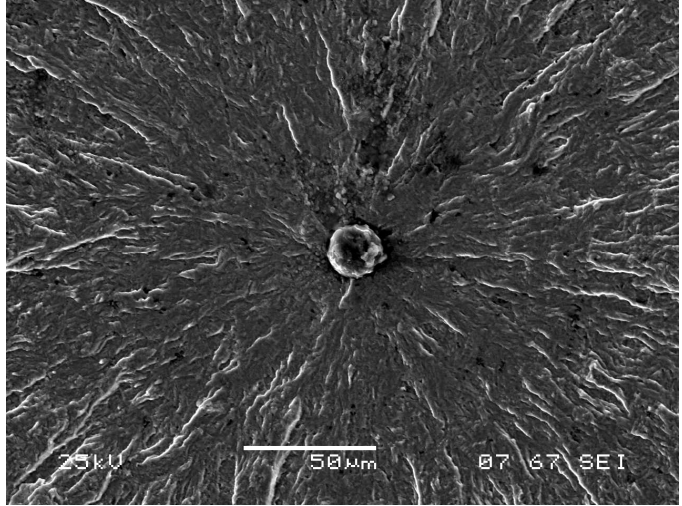
Figures 9 and 10 – Showing an inclusion at the initiation location.

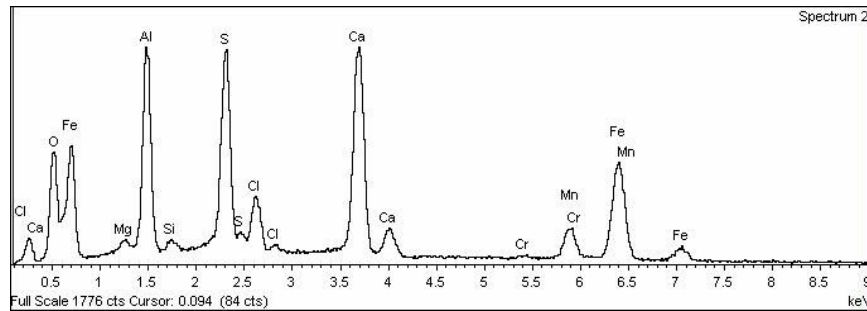
Figure 11 – EDS spectrum showing the elements present in the inclusion (iteration 190 SN 16).

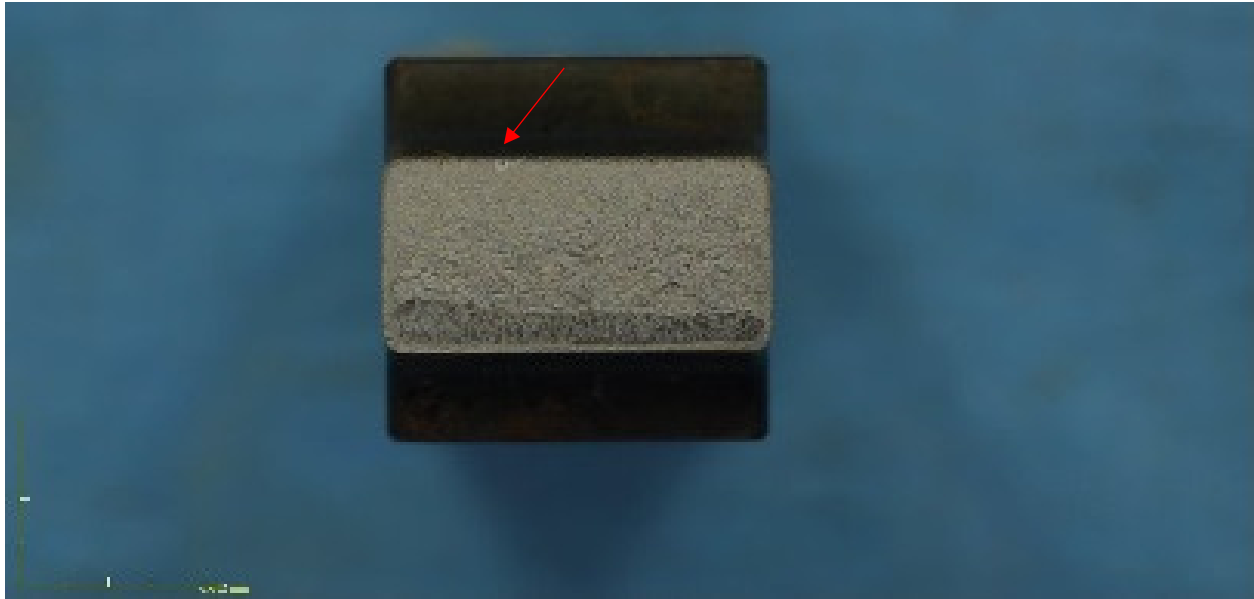
Figure 12 – Showing the fracture surface of iteration 190 SN 17.
Arrow shows location of subsurface burst as the initiation.

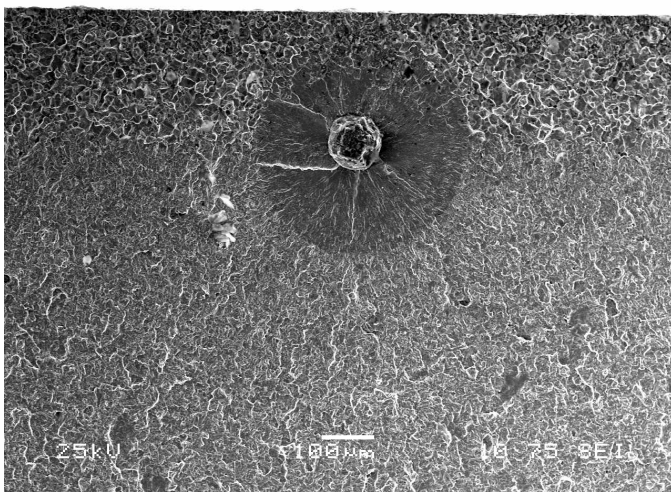
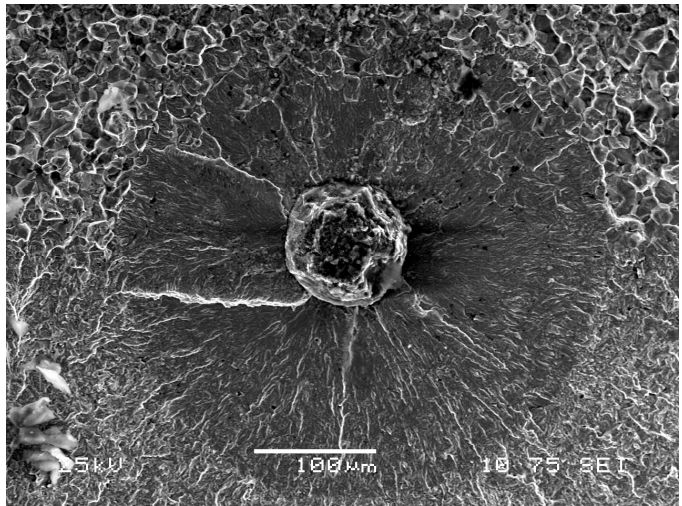
Figures 13 and 14 – Showing an inclusion at the initiation location.

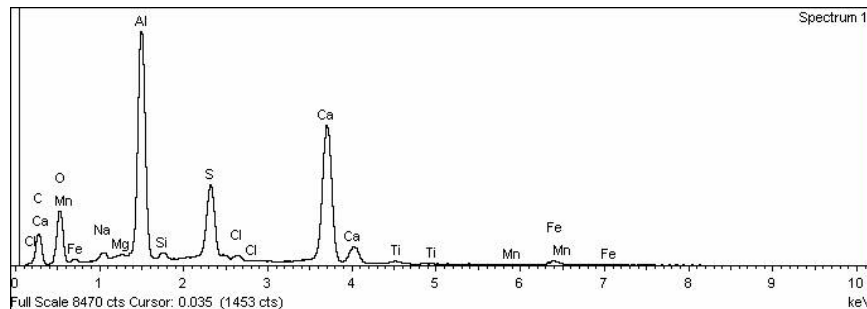
Figure 15 – EDS spectrum showing the elements present in the inclusion (iteration 190 SN 17).

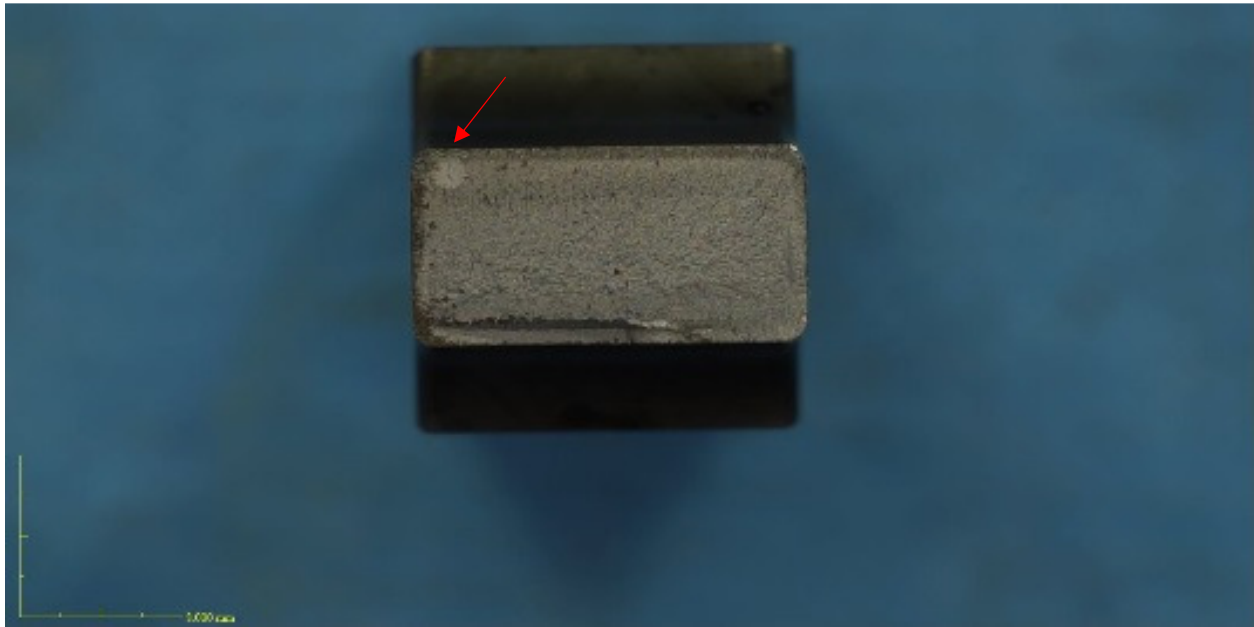
Figure 16 – Showing the fracture surface of iteration 194 SN 9.
Arrow shows location of subsurface burst as the initiation.

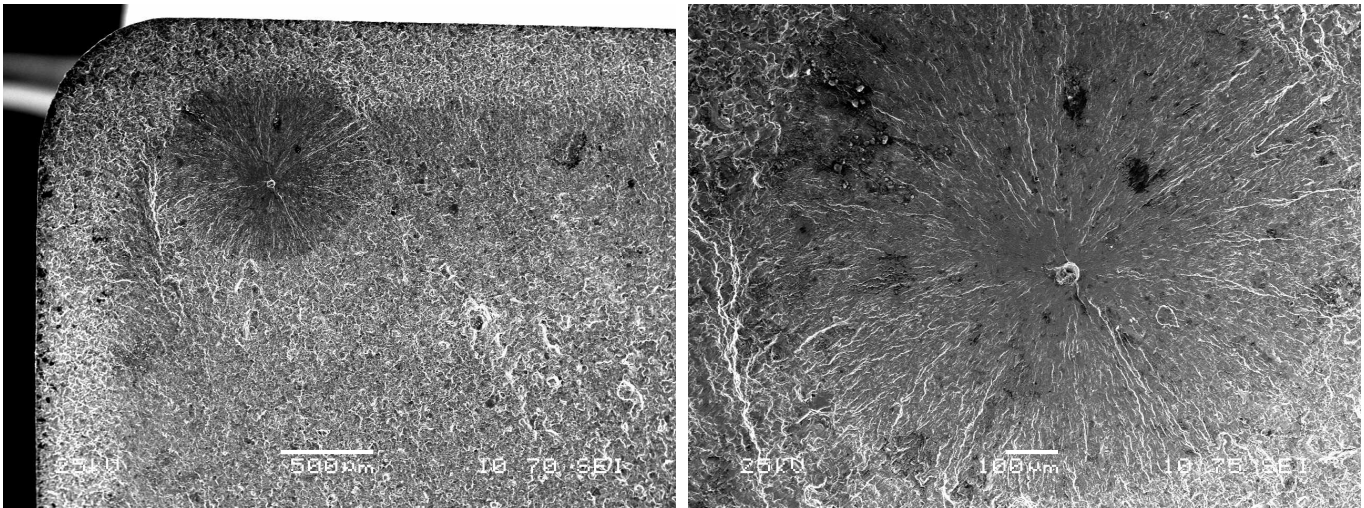
Figures 17 and 18 – Showing an inclusion at the initiation location.

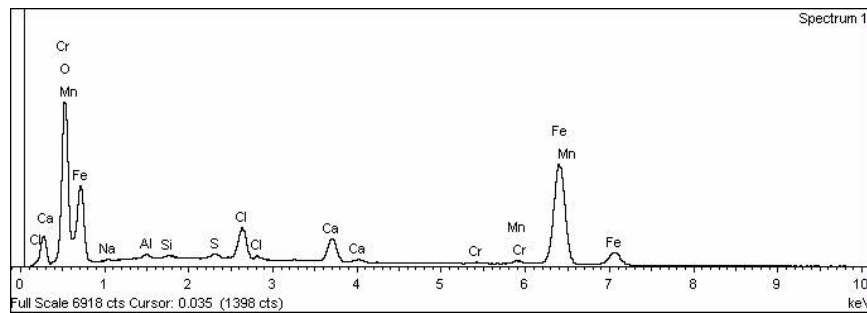
Figure 19 – EDS spectrum showing the elements present in the inclusion (iteration 194 SN 9).
